SPFA-139

Repair of Spray Polyurethane Roof Systems Due to Hail and Wind-Driven Damage

Spray Polyurethane Foam Alliance

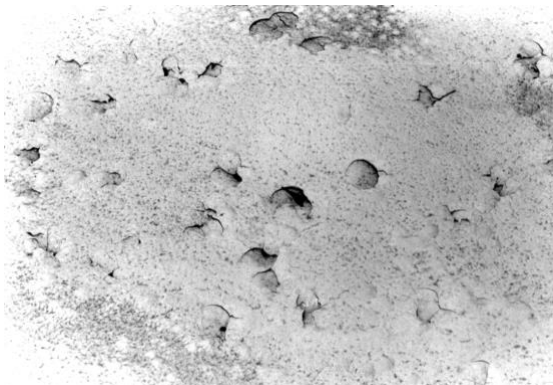
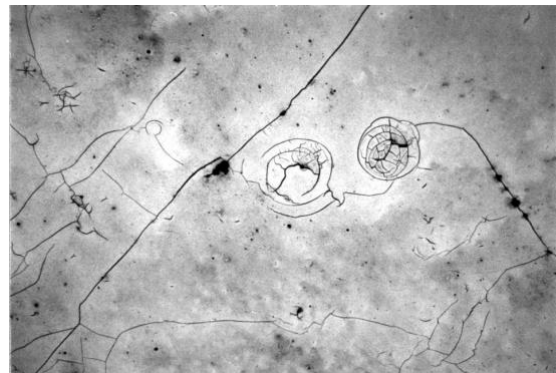
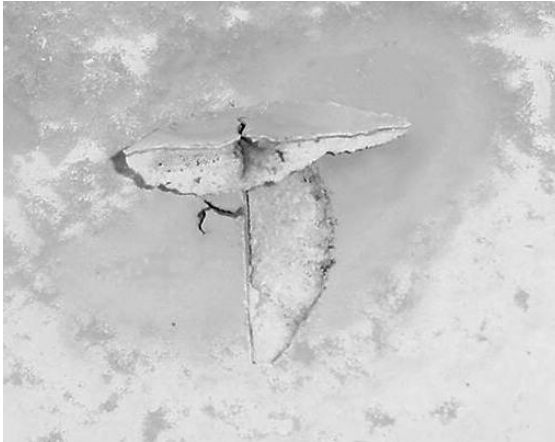
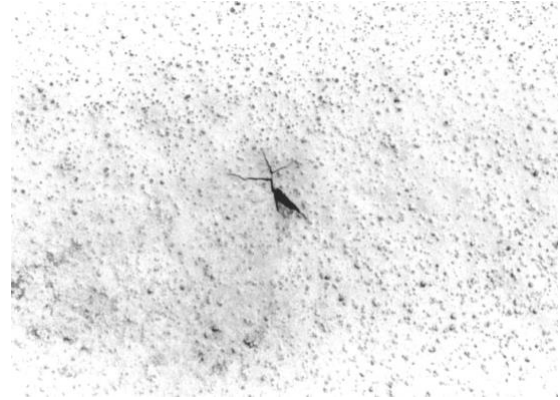
Coating damage can appear as gouges, cracks, and punctures. Hail-induced coating cracks often form patterns shaped like “crow’s feet” or semicircles.

Depending on the hailstone size, shape, and hardness, the underlying foam may be dented, cracked, or gouged. Depressions in SPF dented by hailstones may be 1/8 inch to 3/4 inch deep. Hail damage can be isolated to small areas or can cover the entire roof surface.
